Identify, correct HRSG gas-side corrosion problems

By Bryan Craig, HRST Inc

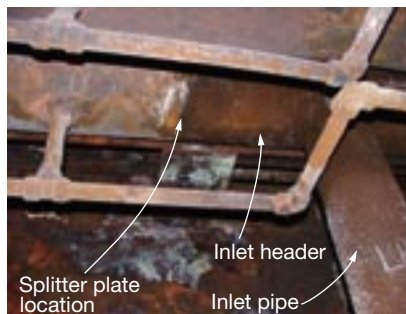
1. Dewpoint corrosion attacks cool feedwater inlet components

given access to the gas side of the HRSG where feedwater enters. Compare the condition of inlet pipes, headers, and tubes to that of nearby piping, headers, and tubes: If components at the feedwater inlet exhibit greater material wastage, dewpoint corrosion is the likely cause (Figs 1-3).

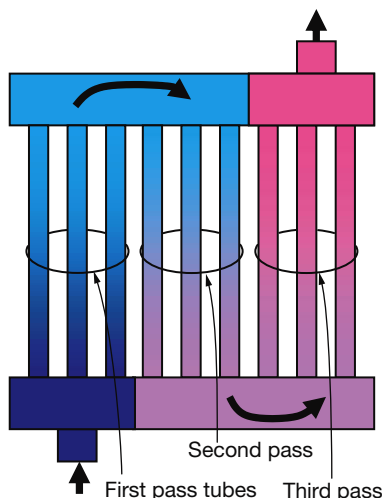
2. Damage is in evidence where first-pass tubes intersect with inlet header and metal is coolest; there's no dewpoint corrosion of second-pass tubes

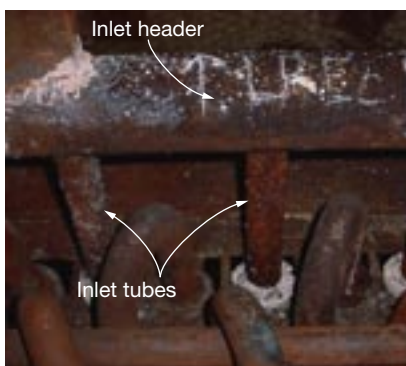
3. Inlet tubes and header exhibit wastage; other tubes are not corroded

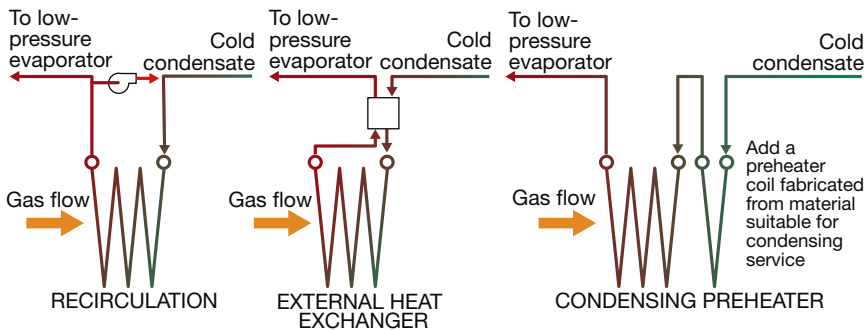
4. Alternatives for maintaining inlet feedwater temperature above the GT exhaust gas dewpoint

Corrective action. Prevent carbon-steel components from operating below the GT exhaust-gas dewpoint. If your system is equipped with a recirculation system or other means for maintaining feedwater inlet temperature above the dewpoint, make sure it is operating properly. If no such system is installed, consider retrofit of a recirculation system, an external heat exchanger, or a preheat coil designed for condensing service to prevent corrosion (Fig 4).

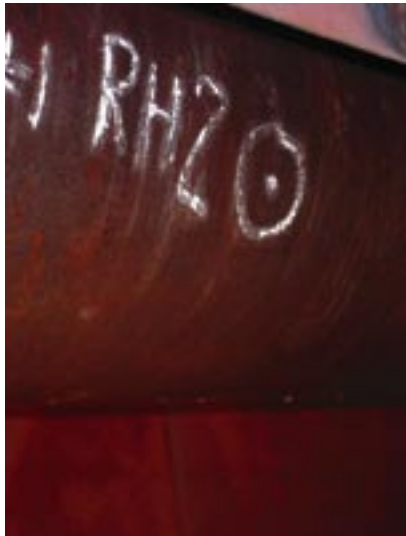
5. Condensate drips from lower reheater header while unit is shut down

This is a relatively recent phenomenon because HRSGs are more likely to spend extended periods offline today than in the past. The large “thermal mass” of HRSG components causes them to lag behind naturally fluctuating ambient temperatures. If a period of relatively cool weather is followed by warm humid conditions, HRSG metal surfaces may remain below the ambient dewpoint for several days, causing the metal to “sweat” like a cold beverage on a summer day (Fig 5). This, of course, increases the corrosion rate of those surfaces.

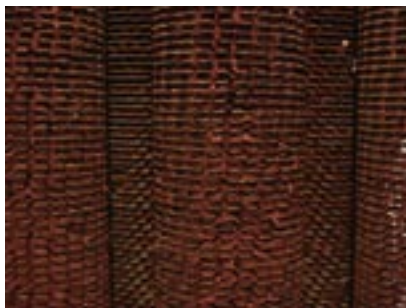
6. Scale between fins is a consequence of offline corrosion

What to look for. HRSGs that operate in a cycling mode typically exfoliate more fin scale than those in base-load service (Fig 6). The scale is flaky in appearance and may fill the gaps between the fins. It also finds its way to access lanes and lower crawl-space floors—often resulting in

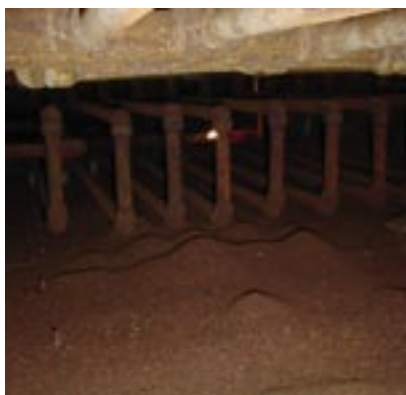
7. Offline corrosion causes debris to accumulate in lower crawl-space

deep piles of debris (Fig 7). Often, offline corrosion is most severe in the middle of the HRSG or one or two access lanes upstream of the stack.

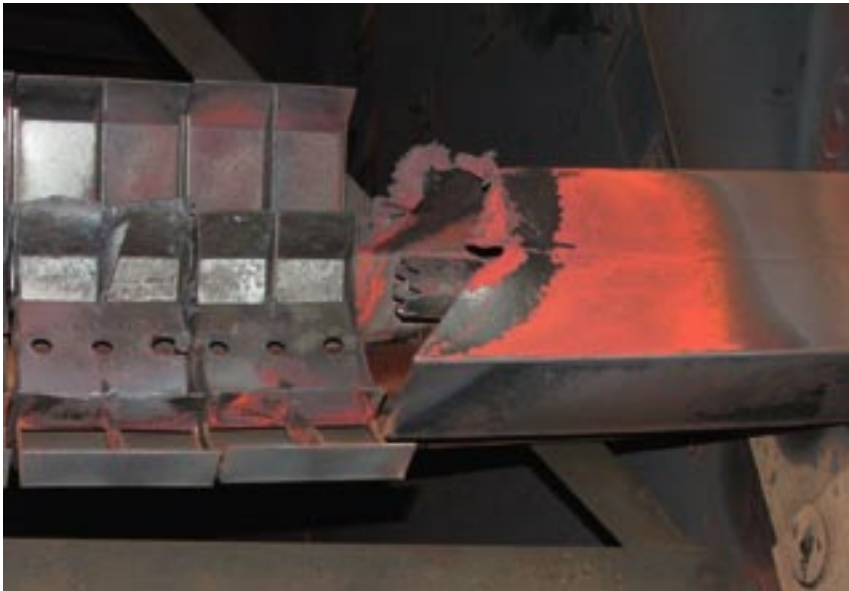
8. High-temperature oxidation damaged this igniter box

fin tips, duct-burner components, and baffles (Figs 8, 9). For example, inlet ducts and firing ducts experience temperatures that are too high for carbon steels commonly used for other components and must be fabricated from stainless steel. By contrast, high-temperature oxidation of pressure parts is highly unlikely because these components have material strength limits that require operating temperatures to be below those at which oxidation becomes a factor.

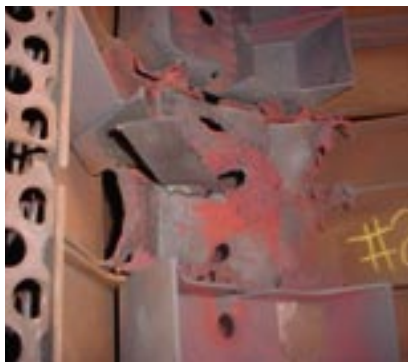
9. Oxidized burner components require replacement

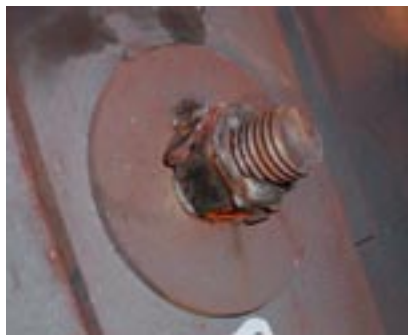
10. Incorrect material use was cause of high-temperature corrosion here

- **Incorrect material selection.** Specifically, the temperature is as expected, but the material is not suitable for use at that temperature (Fig 10). This can occur because of an engineering error, or a material mix-up in the fabrication shop or during field installation.

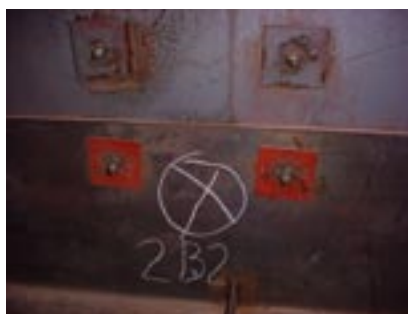
11. Conspicuous color changes in liner system help identify problem

color changes in a liner system can indicate a problem (Fig 11). For example, if a duct liner is silver in color except for a few red sheets or washers, it may be that the wrong material was used for those parts. Note that a red color is not necessarily bad; some liner materials are supposed to be red. Focus your attention on color variations.

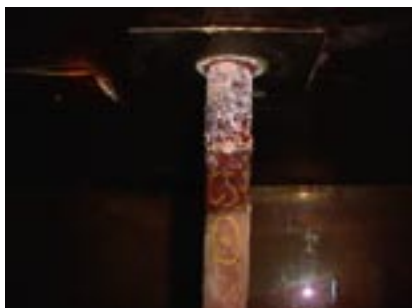
12. Rainwater leaking in through penetration seal corroded economizer vent pipe

water to leak into the HRSG (Figs 12, 13), corroding the pipe and surrounding liner plate, when the seal at the penetration/roof joint is inadequate.

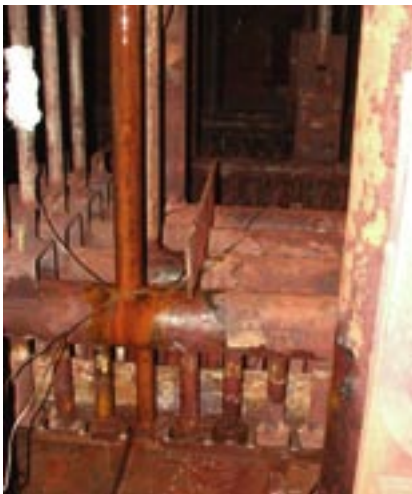
13. Leakage through riser penetration reaches tube bundle below

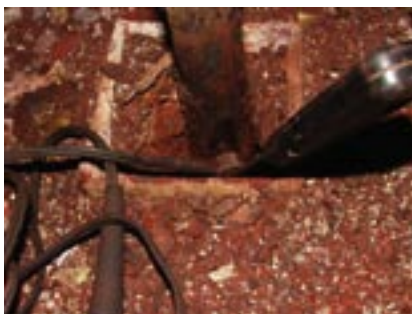
14. Measure thickness of drain-pipe wall to determine corrosion rate. Access is easier if penetration seal is removed from casing exterior

few drain penetration seals from suspect locations and inspect the pipe both visually and with ultrasound (Fig 14). This is relatively easy with clamped-on fabric penetration seals, but is more challenging with stainless steel bellows.

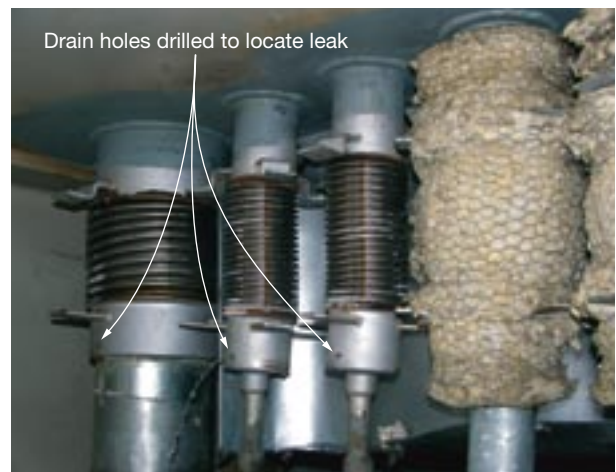
15. Drill holes in base of penetration seals to detect leaks. Allow holes to remain, enabling GT exhaust gas to heat seal and minimize opportunity for corrosion

Corrective action. Bore a small hole through the metal ring at the bottom of a fabric or metal-bellows penetration seal (Fig 15), permitting a small amount of exhaust gas to leak through and warm the pipe.

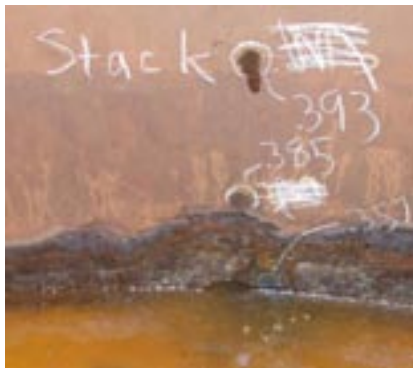
16. Corroded stack base. Numbers on wall are ultrasonic thickness measurements. Material wastage is significant

What to look for. Inspect for standing water or mud in the stack base. If water is not present, check for signs of a previous waterline. Heavy scaling on the stack interior near the base is an indicator of previous corrosion. If stack-wall corrosion appears to exist, check metal thickness in the affected area and above it (Fig 16).

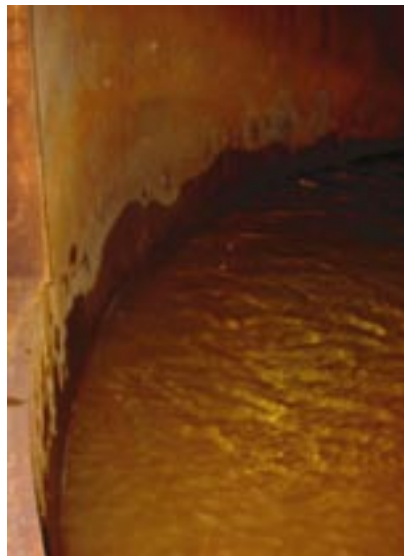
17. Inspector found approximately 8 in. of standing water in stack base

Corrective action. Avoid having standing water in the stack base (Fig 17). Check stack drains open when the unit is offline and verify that drain piping is sloped properly. Remove any debris that could restrict flow of rainwater from the drain. Shovel any loose debris out of the stack base. CCJ OH
