7EA Users focus on repairs, upgrades to improve performance, reduce emissions

USER GROUP ACTIVITIES

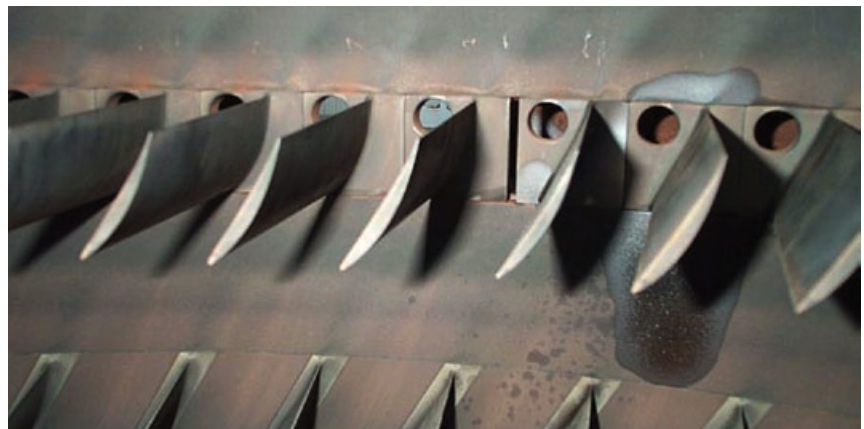
1. Gaps between adjacent blades occur when shims wear and fall into the flow stream, causing foreign object damage

Anderson specifically addressed the 7EA's loose-blade problem commonly associated with the fifth compressor stage. These stator vanes, as well as those in other stages, often loosen in the casing groove over time (Fig 1). Here's how Anderson explained the reason for this condition:

vanes to work their way into the flow path, even in the lower half of the compressor. Compressor performance suffers as the shims protrude into the flow path. However, shims have been observed to migrate 1/8 in. or more into the flow stream, which can initiate a flow disturbance that produces a strong once-per-revolution stimulus at the tips of downstream rotor blades.

In the extreme, when sufficient wear occurs at shim tabs—often referred to as “ears”—because of blade movement and the sharp corners in the casing groove, shims can release into the flow stream. Result is downstream foreign-object damage.

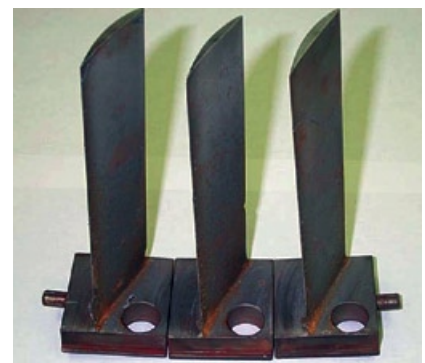
3. Pinned blades still "rock solid" after 700 starts and 8000 hours in service, despite heavy foreign object damage

Anderson said that PTI has applied its solution on 12 engines. The fleet leader had 700 starts and 8000 hours of operating time with the fix by mid 2004. Despite heavy foreign object damage (Fig 3), the pinned blades are still “rock solid.”

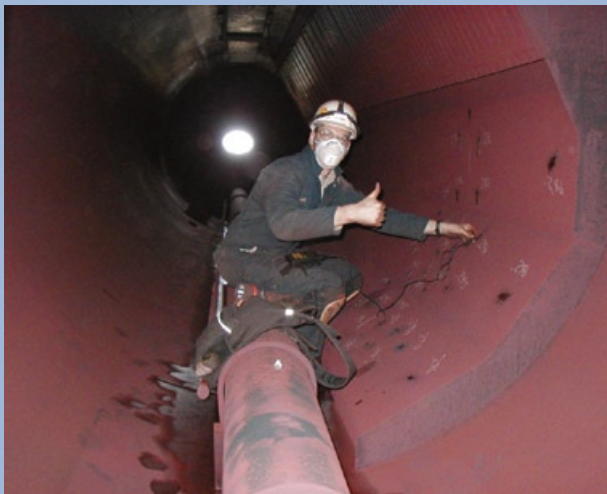
2. Ultrasonic thickness testing revealed no problems in this low-pressure drum, but does that mean the rest of the boiler is fine?

FAC is most common in low- and intermediate-pressure evaporators, noted Stanley, so inspectors should always look carefully in their steam drums (Fig 2) for FAC indications. But if no problems are found, does that mean everything is OK? "No," he said. The weak link in the sys-

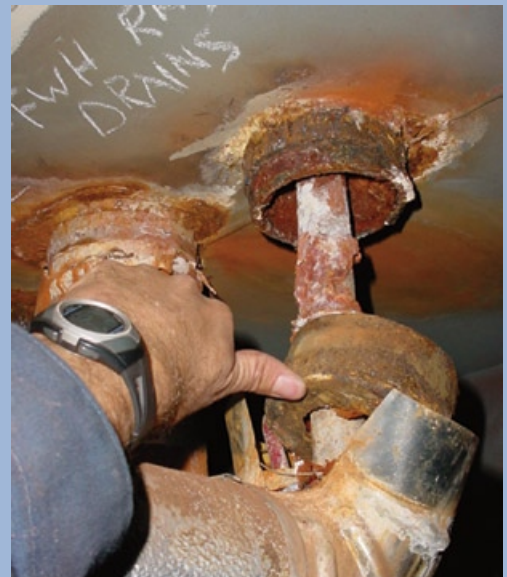
4. Drain pipe corrosion remained hidden until fabric seal was removed (right)

Casing penetration seals. The second part of Stanley's presentation addressed the inspection of casing penetration seals through HRSG liners and the casing. HRSGs that sit idle, and are exposed to rain, can have significant corrosion attack. The cause is improper roof casing seals around hanger rods, access doors, and pipe penetrations. Many floor casing penetration seals under superheaters and reheaters fail from a combination of design- and cycling-related problems (Fig 3). Pressure-part corrosion inside the pipe penetration seals, especially in the floor, can be a hidden problem. The seal or internal liner must be removed to perform a good inspection (Fig 4).

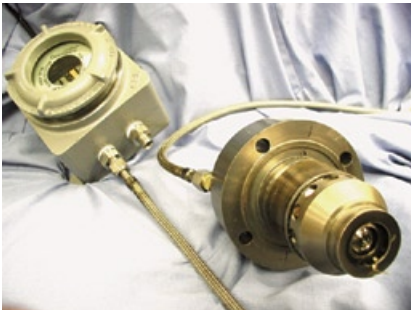
5. Optically instrumented fuel nozzle (foreground) is linked to signal processor at left by fiber optic cable

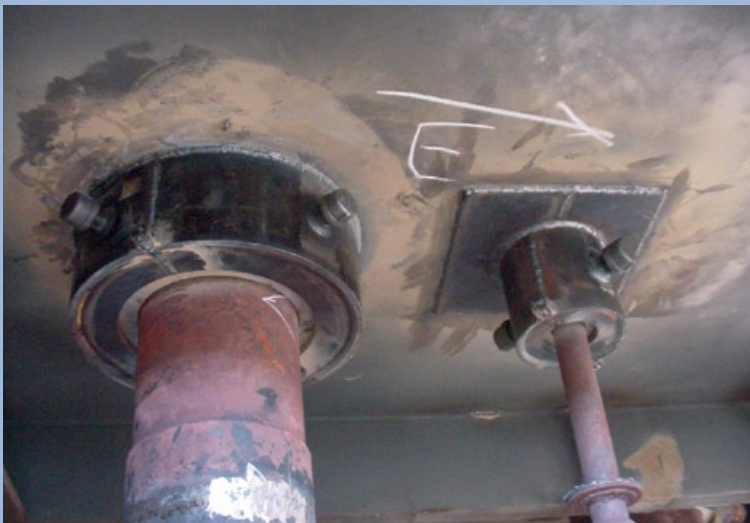
5. Retrofit pipe penetration seal designed by HRST is said to be increasingly popular

Stanley also showed the HRST retrofit pipe penetration seal that many plants have installed to improve their seal arrangement (Fig 5).
